**Flood Control Project Maintenance
Levee Inspections**

Fall 2013 Levee Maintenance Deficiency Summary Report

Lake County Watershed Protection District

Levee Inspection Report By Mile - Fall 2013

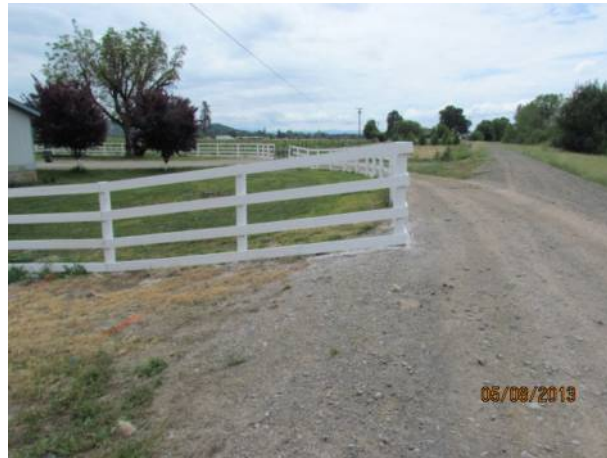
Levee Mile Report Line	4
Start Levee Mile	0.12
End Levee Mile	0.12
Location	Land Side
Category	Earthen Levee
Item	Encroachments
View of the unauthorized encroachment fence along landside slope.	
rduffey_f_20130919_869.JPG

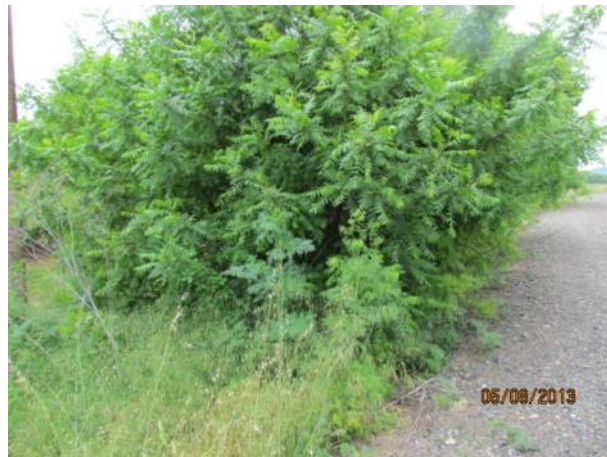
Levee Mile Report Line	5
Start Levee Mile	0.25
End Levee Mile	0.25
Location	Land Side
Category	Earthen Levee
Item	Trim / Thin Trees
Remove the trees from the landside slope.	
rduffey_f_20130919_868.JPG

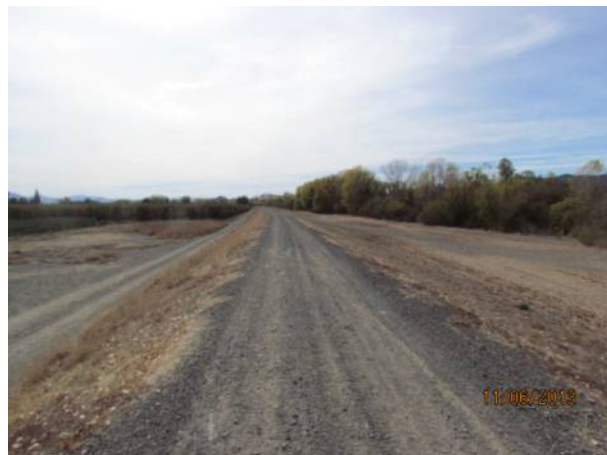
Levee Mile Report Line	6
Start Levee Mile	1.72
End Levee Mile	1.72
Location	Land Side
Category	Earthen Levee
Item	Vegetation
View of the mowed slopes.	
rduffey_f_20131118_157.JPG

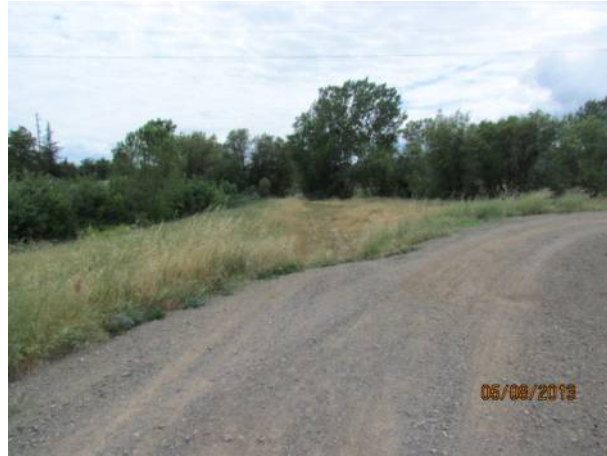
Levee Mile Report Line	7
Start Levee Mile	2.29
End Levee Mile	2.29
Location	Water Side
Category	Earthen Levee
Item	Slope Stability

View of the vehicle erosion along the waterside slope.

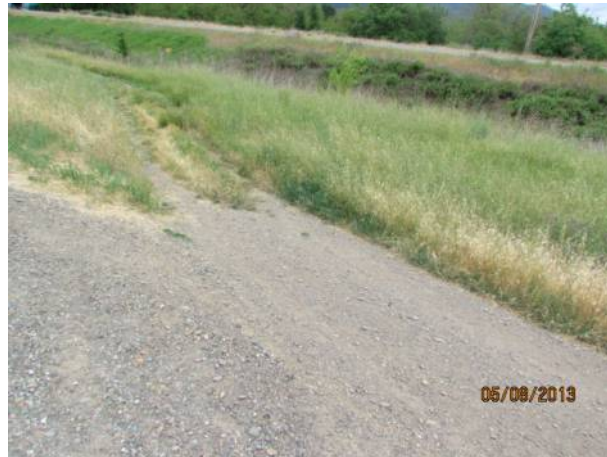
Levee Mile Report Line	8
Start Levee Mile	2.37
End Levee Mile	2.37
Location	Water Side
Category	Earthen Levee
Item	Slope Stability

View of the vehicle erosion along the waterside slope.

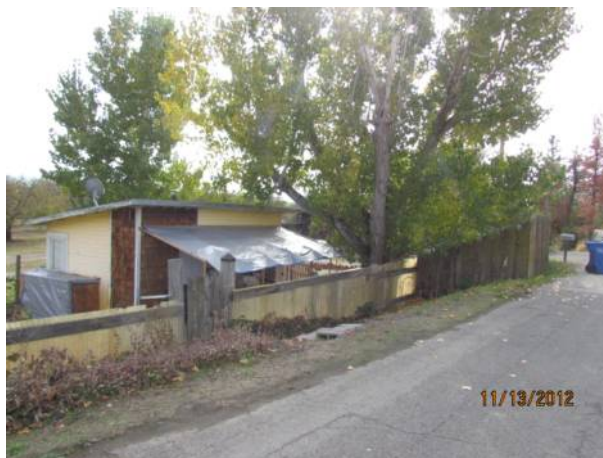
Levee Mile Report Line	10
Start Levee Mile	2.40
End Levee Mile	2.40
Location	Land Side
Category	Earthen Levee
Item	Encroachments

View of a building & fence along the toe of the levee.

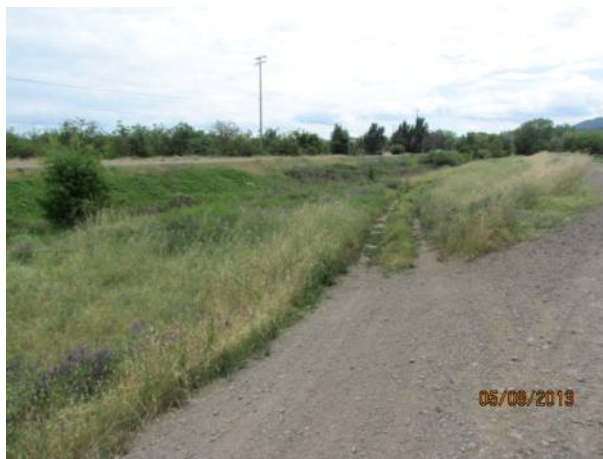
Levee Mile Report Line	11
Start Levee Mile	2.40
End Levee Mile	2.40
Location	Water Side
Category	Earthen Levee
Item	Slope Stability

View of the vehicle erosion along the waterside slope.

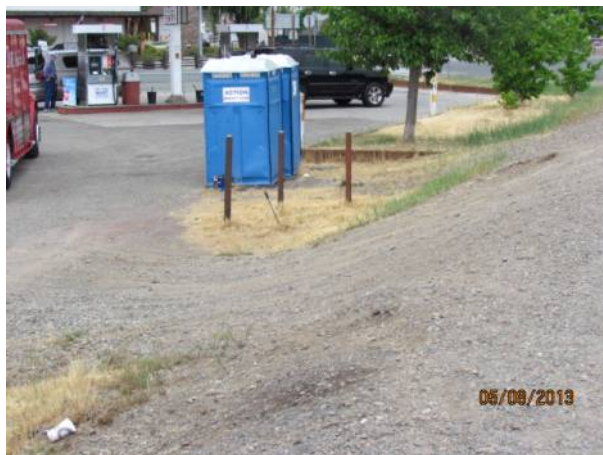
Levee Mile Report Line	12
Start Levee Mile	2.42
End Levee Mile	2.42
Location	Land Side
Category	Earthen Levee
Item	Slope Stability

View of vehicle erosion along landside slope.

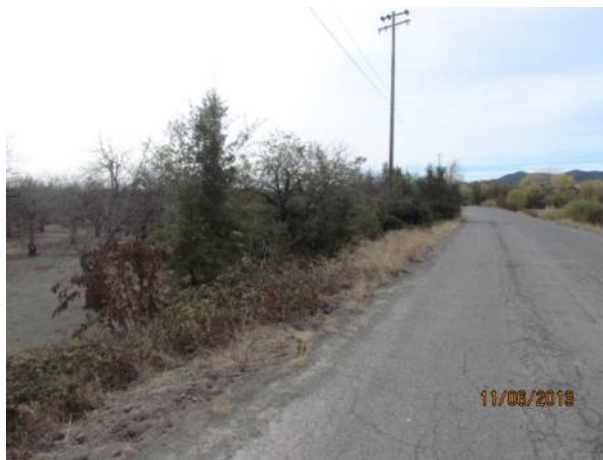
Levee Mile Report Line	13
Start Levee Mile	2.48
End Levee Mile	2.55
Location	Land Side
Category	Earthen Levee
Item	Vegetation

View of the vegetation along the landside slope.

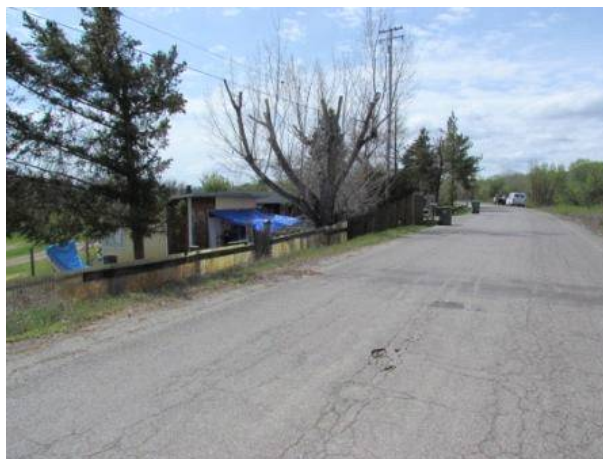
Levee Mile Report Line	14
Start Levee Mile	2.58
End Levee Mile	2.61
Location	Land Side
Category	Earthen Levee
Item	Encroachments

View of the fences at the L/S toe.

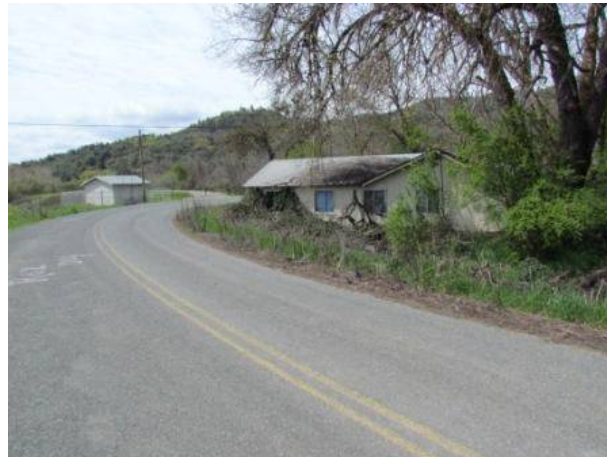
Levee Mile Report Line	3
Start Levee Mile	0.20
End Levee Mile	0.20
Location	Land Side
Category	Earthen Levee
Item	Encroachments

View of the vegetation and building next to the landside toe of levee.

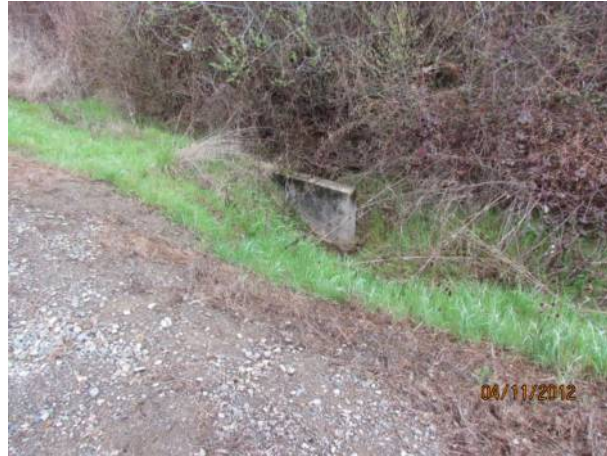
Levee Mile Report Line	5
Start Levee Mile	0.39
End Levee Mile	0.39
Location	Land Side
Category	Earthen Levee
Item	Slope Stability

View of erosion along slope of the levee by both sides of the headwall.

5	0.39	0.39	Earthen Levee	Slope Stability	LS	M Ma	S1 : Repair slope instability.	39.185160 ° -122.911138 °	39.185160 ° -122.911138 °	8 Y
DWR ID: DWR_NA0009_02_s_2012_8										
6	1.03	1.04	Earthen Levee	Vegetation	LS	M Ma	V2 : Remove the wild growth other than native grasses from the levee slopes.	39.177218 ° -122.913673 °	39.176992 ° -122.913642 °	7 Y
DWR ID: DWR_NA0009_02_s_2012_7										
7	1.05	1.05	Earthen Levee	Encroachments	LS	M En	BU : Building	39.176875 ° -122.913685 °	39.176875 ° -122.913685 °	5 Y
DWR ID: DWR_NA0009_02_s_2012_5										
8	1.06	1.06	Earthen Levee	Encroachments	LS	M Ma	TR : Tree or limb	39.176835 ° -122.913558 °	39.176835 ° -122.913558 °	3 Y
DWR ID: DWR_NA0009_02_s_2012_3										
9	1.06	1.06	Earthen Levee	Encroachments	LS	U En	FE : Fence	39.176815 ° -122.913540 °	39.176815 ° -122.913540 °	2 Y
DWR ID: DWR_NA0009_02_s_2012_2										
10	1.15	1.18	Earthen Levee	Encroachments	LS	U En	FE : Fence	39.175460 ° -122.913400 °	39.175075 ° -122.913392 °	10 Y

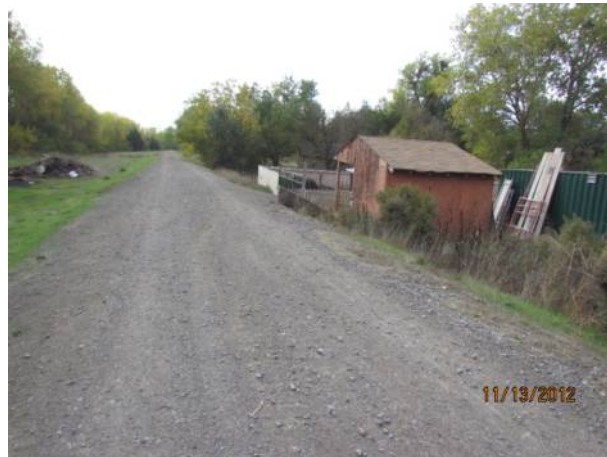
Levee Mile Report Line	7
Start Levee Mile	1.05
End Levee Mile	1.05
Location	Land Side
Category	Earthen Levee
Item	Encroachments

View of building & vegetation along the levee toe.

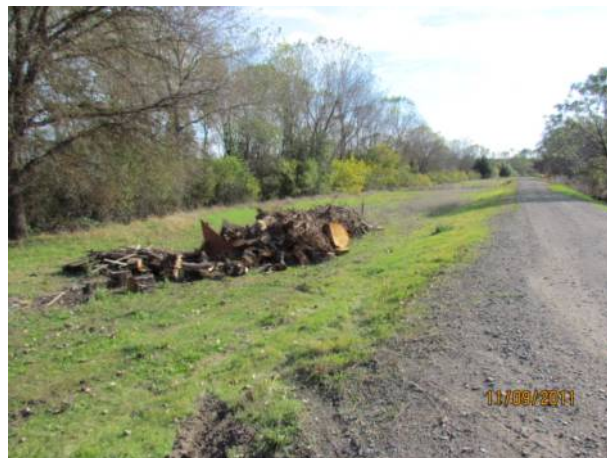
Levee Mile Report Line	8
Start Levee Mile	1.06
End Levee Mile	1.06
Location	Land Side
Category	Earthen Levee
Item	Encroachments

View of the tree prunings on the W/S toe.

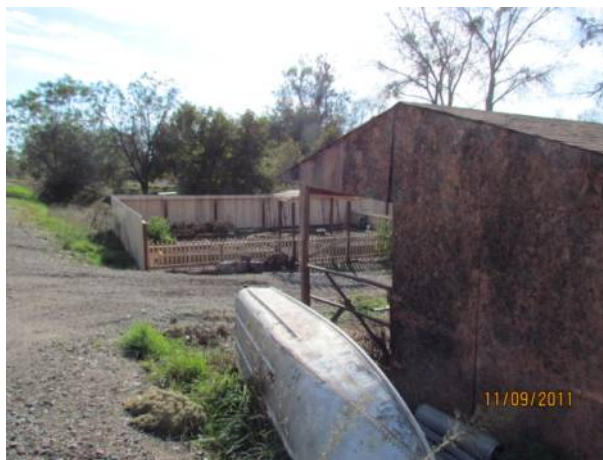
Levee Mile Report Line	9
Start Levee Mile	1.06
End Levee Mile	1.06
Location	Land Side
Category	Earthen Levee
Item	Encroachments

View of the building & fence along the L/S toe.

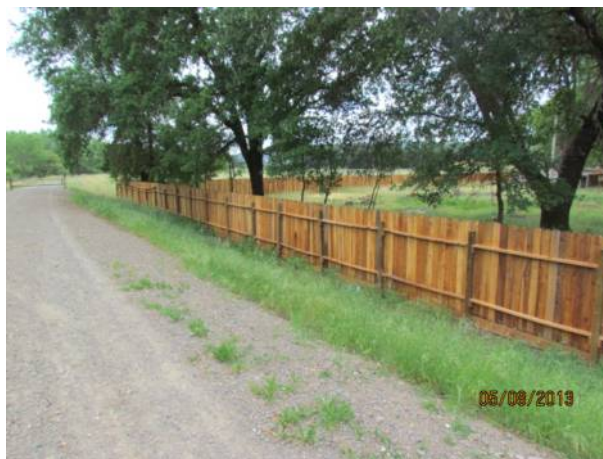
Levee Mile Report Line	10
Start Levee Mile	1.15
End Levee Mile	1.18
Location	Land Side
Category	Earthen Levee
Item	Encroachments

View of the unauthorized fence along the landside toe.

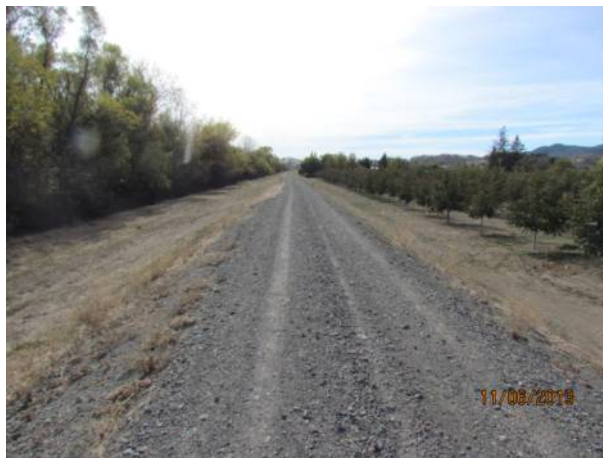
Levee Mile Report Line	11
Start Levee Mile	1.80
End Levee Mile	1.80
Location	Land Side
Category	Earthen Levee
Item	Vegetation

View of the mowed slope.

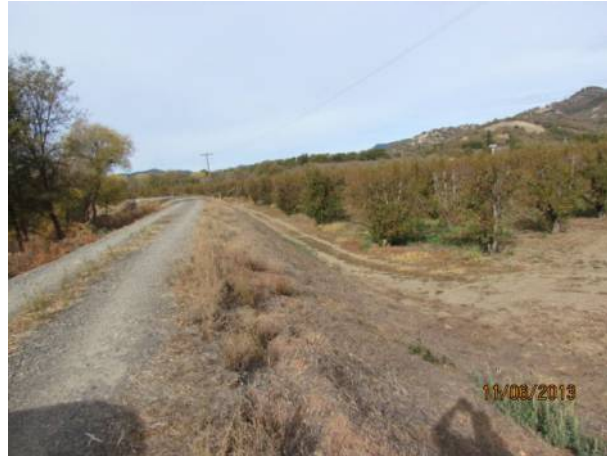
Levee Mile Report Line	1
Start Levee Mile	0.92
End Levee Mile	0.92
Location	Land Side
Category	Earthen Levee
Item	Vegetation

View of the removed vegetation from both slopes.

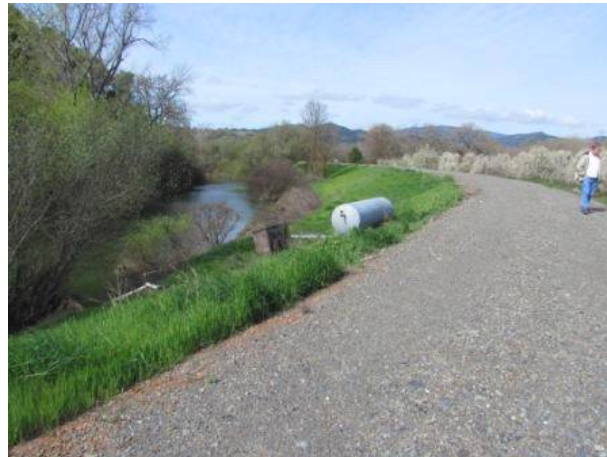
Levee Mile Report Line	2
Start Levee Mile	0.97
End Levee Mile	0.97
Location	Water Side
Category	Earthen Levee
Item	Encroachments

View of a tank that needs to be removed from the W/S slope.

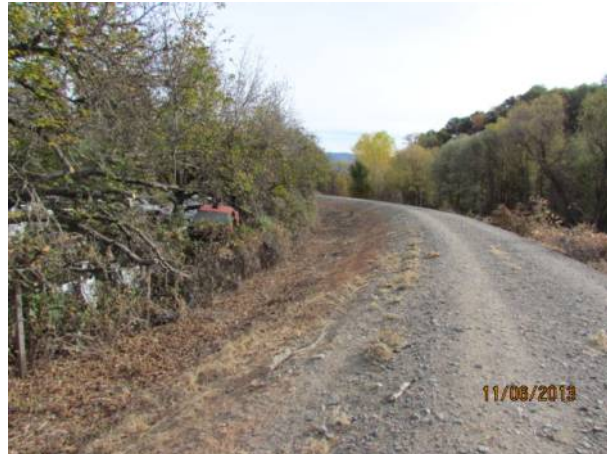
Levee Mile Report Line	3
Start Levee Mile	1.06
End Levee Mile	1.12
Location	Land Side
Category	Earthen Levee
Item	Vegetation

View of the vegetation removed from the landside slope.

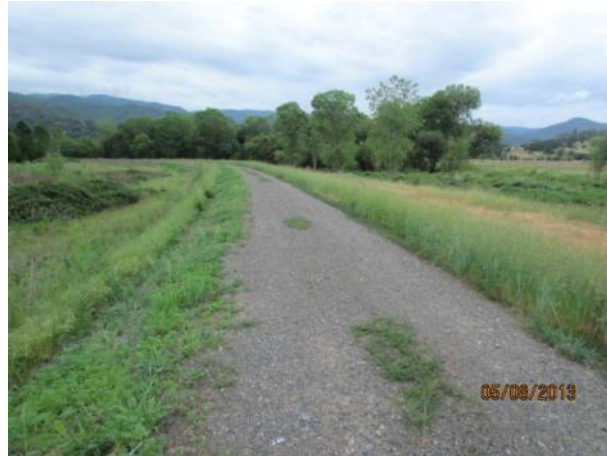
View of tall native grasses on both slopes.

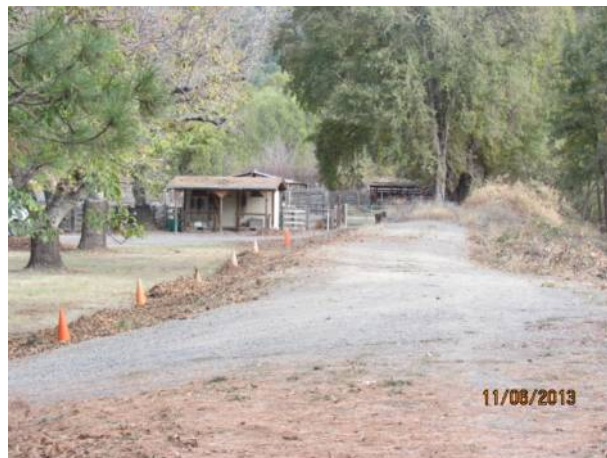
Levee Mile Report Line	5
Start Levee Mile	1.43
End Levee Mile	1.46
Location	Land Side
Category	Earthen Levee
Item	Trim / Thin Trees

View of the removed oleanders along the landside slope.

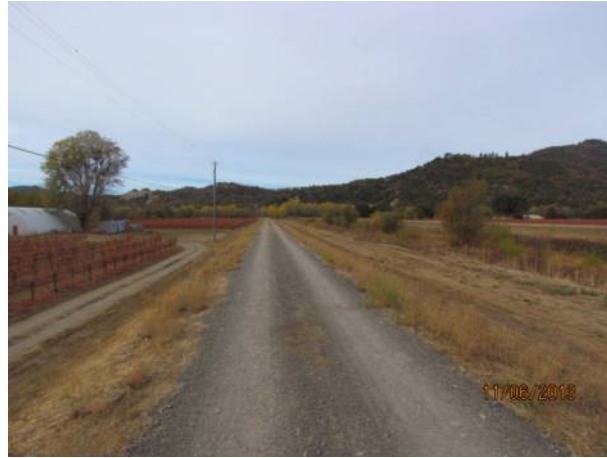
View of the mowed slopes.
